**Freedom Under The Sun** LLC.  
A Vermont Home And Property Inspection Company  
39 Carver Street Brandon, Vermont 05733  
Telephone 1-888-247-1299 Fax (802) 247-1244  
E-mail: [Kirk@Vermont-HomeInspector.com](mailto:Kirk@Vermont-HomeInspector.com)  
Website: [www.Vermont-HomeInspector.com](http://www.Vermont-HomeInspector.com)

89 Trescott Road, Hanover, New Hampshire 03750

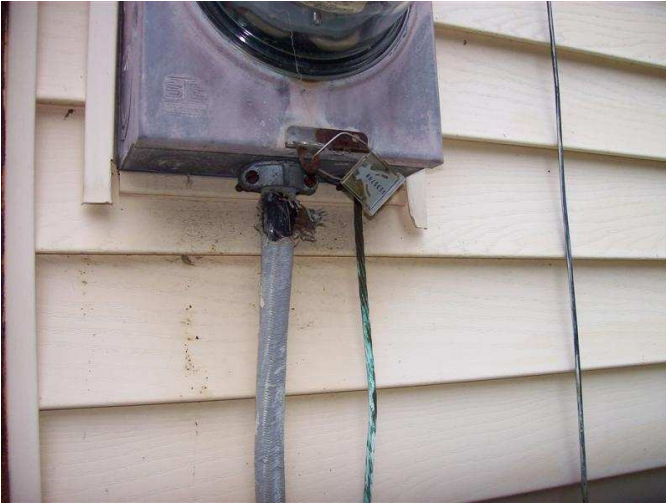
The service entrance cable, from the drip loop to the meter and from the meter to the main panel, has no weather protection. The sheathing is no longer water tight and very tender. This cable can now allow moisture to enter in among the conductors.

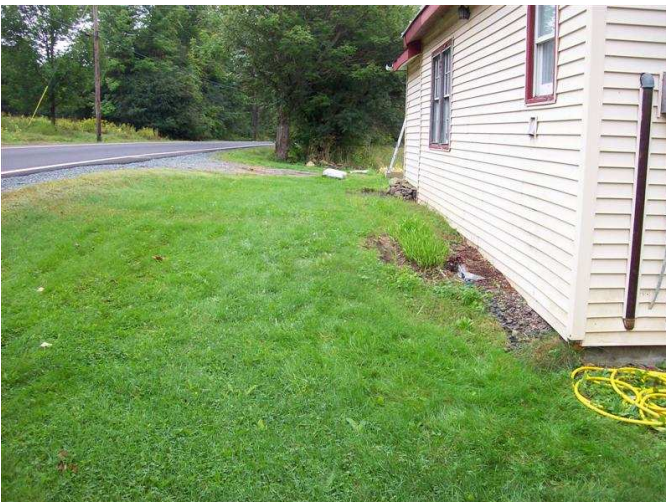
The front of the dwelling, toward Trescott Road, has a finish grade that is banked up above the siding. This condition allows water into the foundation and it is exposing the sills to moisture. The finish grade of any structure should be, at a minimum, six (6) inches below the bottom of the siding. Re-grading this location will be important and will reduce the amount of water accessing the basement.

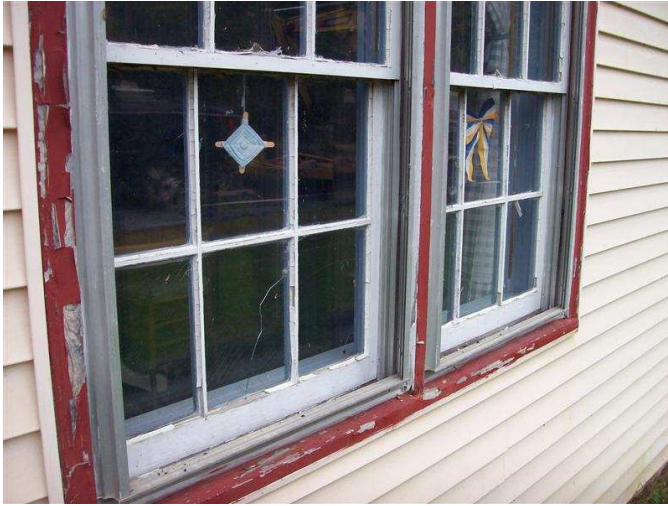
The windows facing Trescott Road, and some of the others, are single glazed windows in poor condition. Replacing them would improve the overall insulation value. Some sills, jambs, and window trim are soft and punky from water damage.

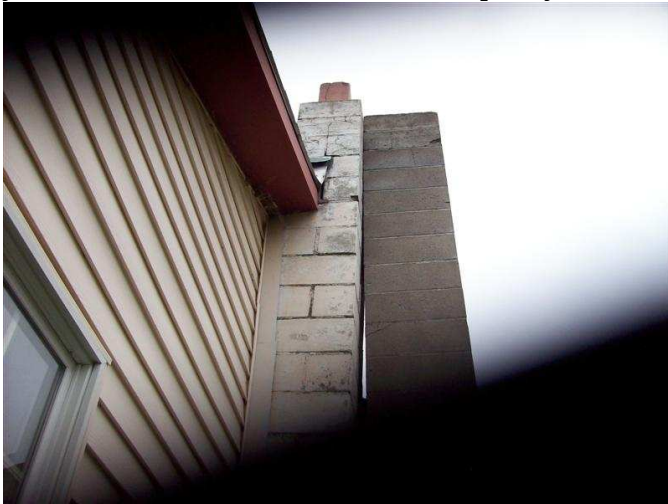
This white masonry chimney is failing. The chimney has settled away from the house and is showing signs that the masonry is in very poor condition. The white chimney is now placing preventable stress on the other chimney. It has cracked the grey chimney at the third course of masonry near the top.

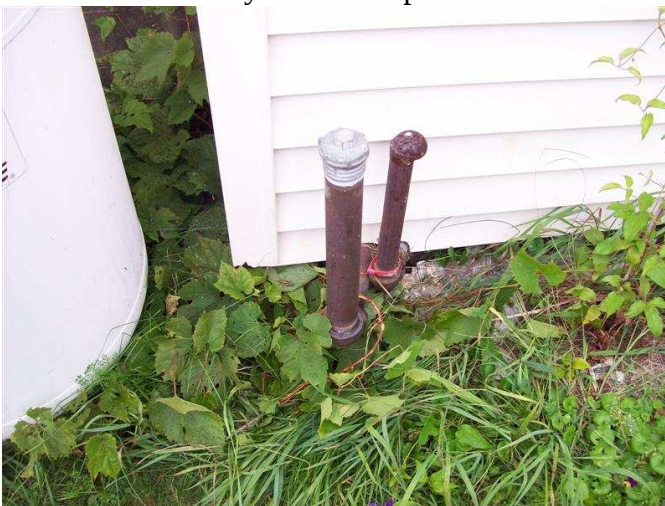
The oil fill pipe and vent pipe are not equal in size. When under pressure during filling the tank could cause excess pressure on the fuel tank. Seeking the opinion of your fuel company will be necessary as to whether this item should be changed.

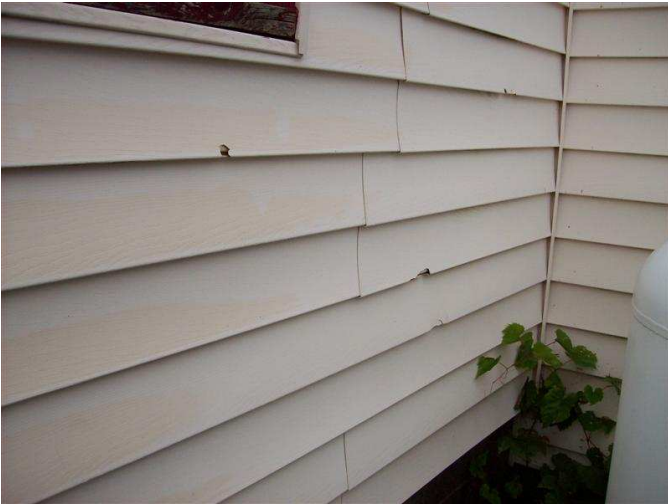
Vinyl siding has been damaged in several locations. These penetrations will need to be sealed to prevent moisture from damaging the structural material within the wall cavity.

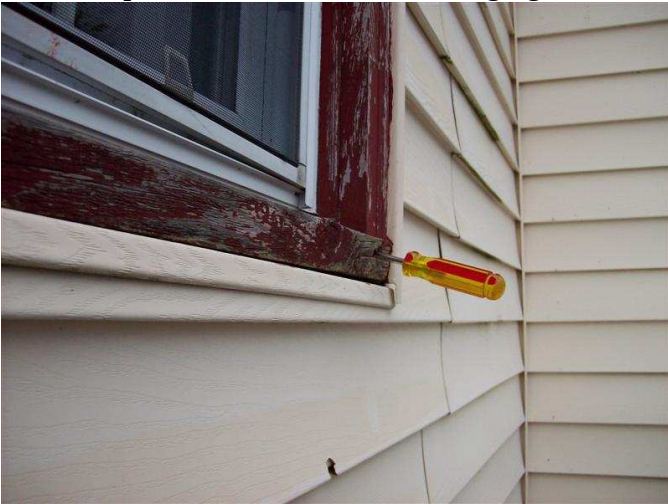
This window sill is soft and punky and will require repair.

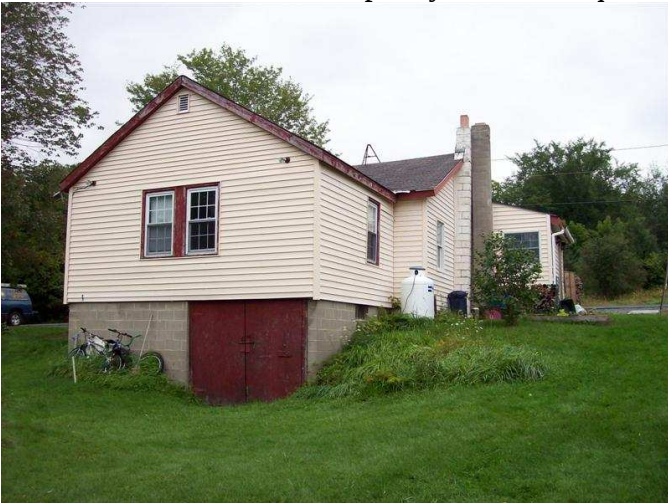
This photo shows the soffits and fascia boards need to be scraped, primed and painted.

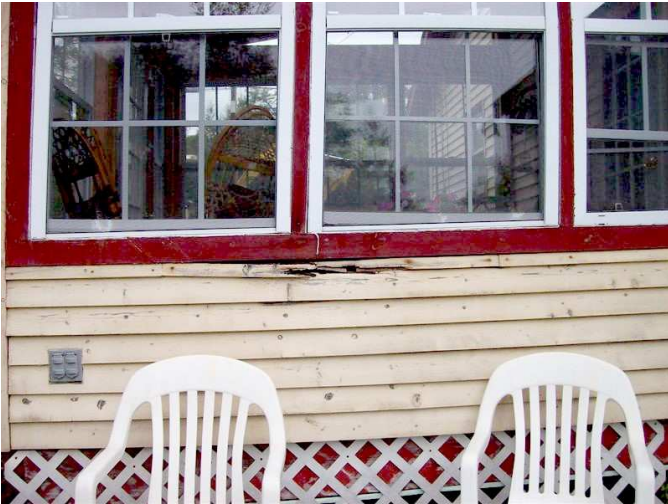
The rear exterior wall of this porch is damaged from moisture. It has rotted the siding. This wall and the front entrance wall perpendicular to this rear wall, are positioned on a metal post and concrete blocks. These materials are not properly supporting this corner of the porch. The porch should be placed on properly installed footings. The porch has dropped far enough to break apart the replacement windows and they will not close properly. The windows are no longer plumb and level.

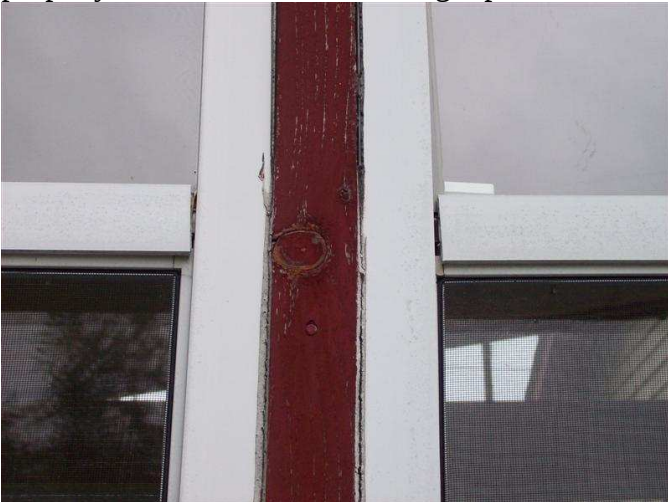
This is a photo of the vinyl windows being pulled apart.

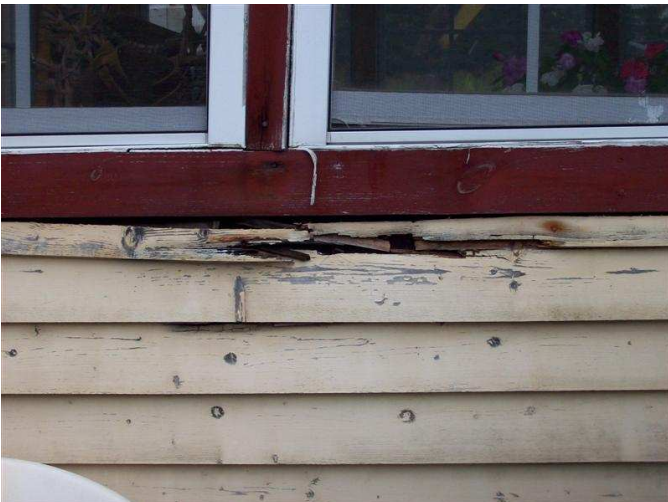
This is a closer view of the water damage to the siding.

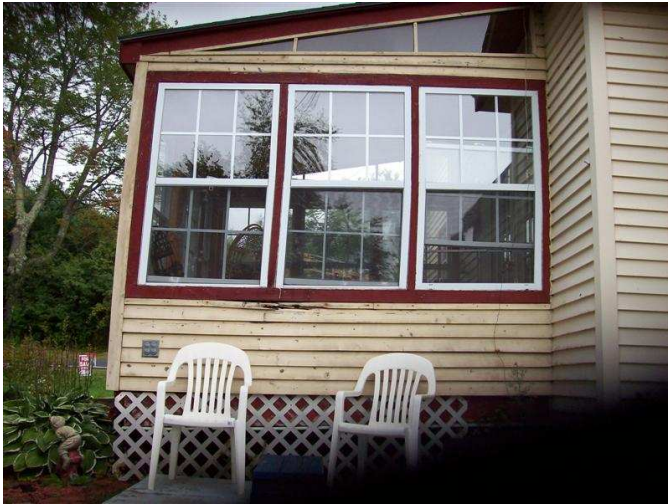
This photo shows the windows bowing under the pressure.

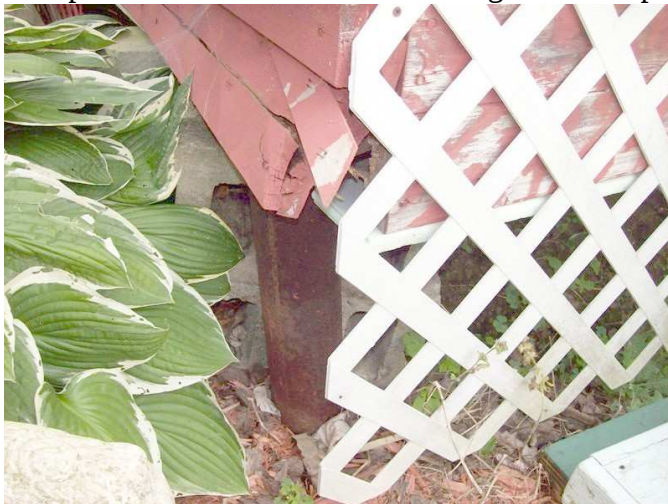
This pipe column is no longer plumb and vertical. The column has damaged the supporting materials. The concrete blocks, utilized for temporary support, are not on proper footings and are no longer stable in supporting the load.

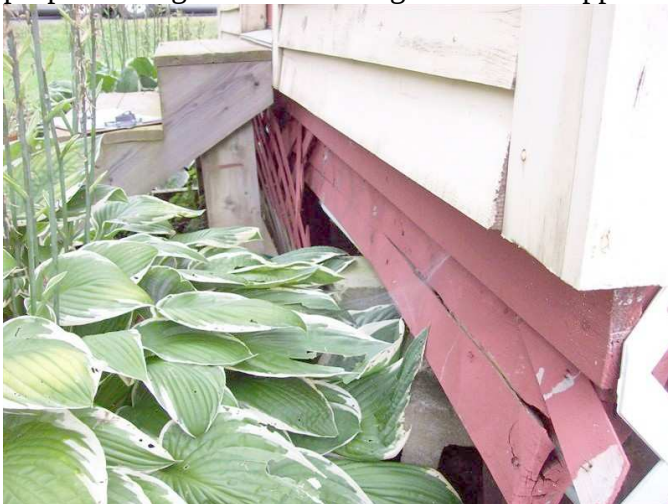
The damage to the porch is being transferred across the front of the entire porch.

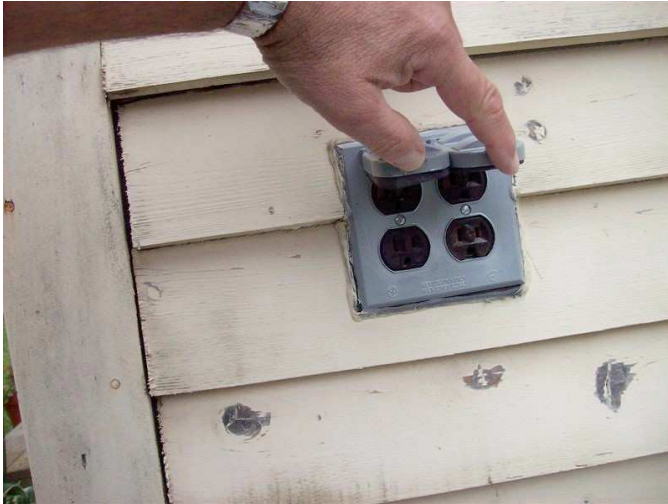
The exterior outlets are not protected by Ground Fault Circuit Interrupters (GFCI).

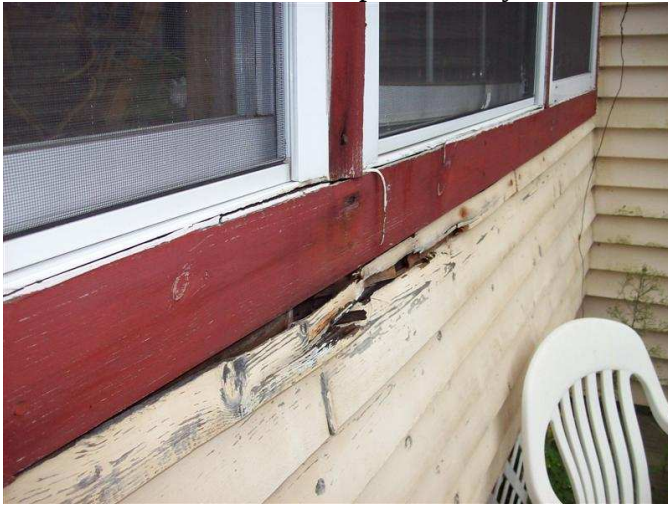
This is a closer view of the porch and the moisture damage.

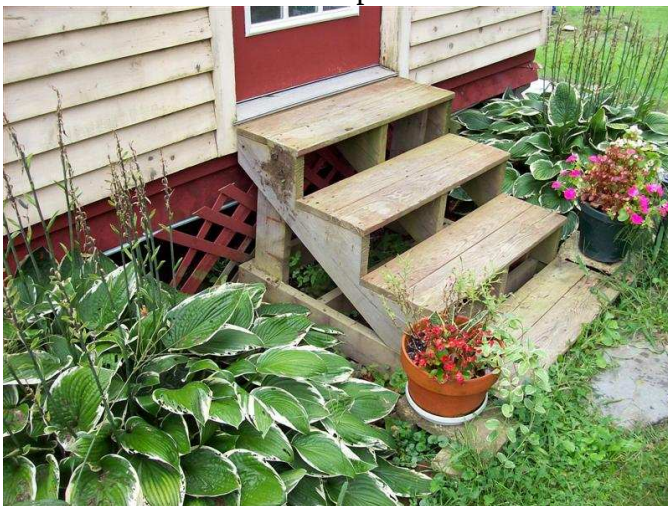
The porch stairs require proper handrails in an effort to prevent a fall.

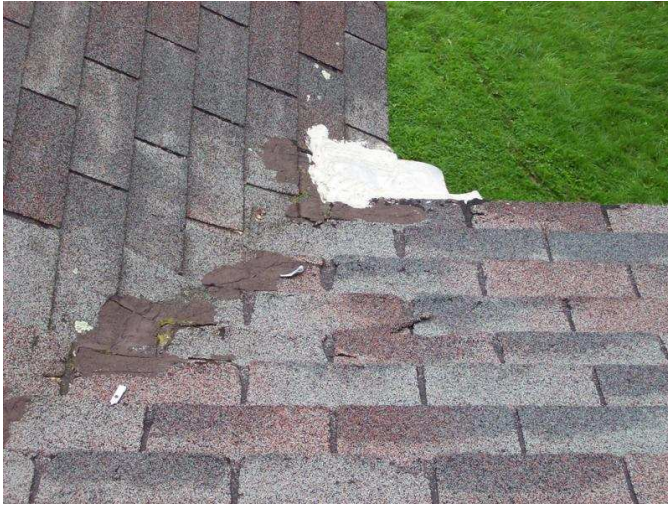
Both valleys of the roof have signs of damaged shingles, patching in an attempt to prevent leaking, and shingles that are curled from sun and age.

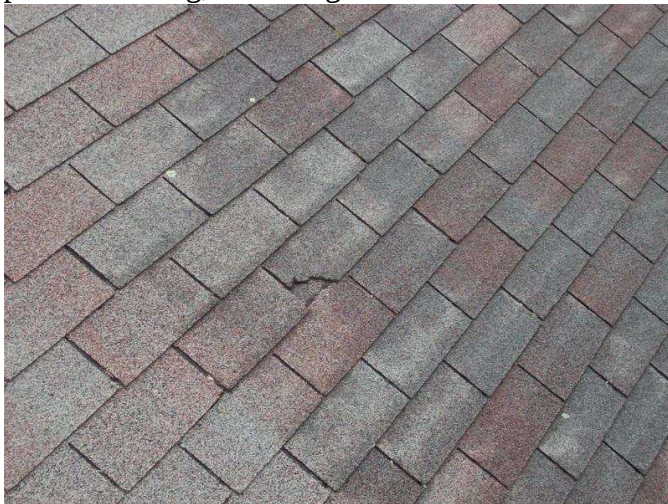
There are several damaged shingles and broken tabs.

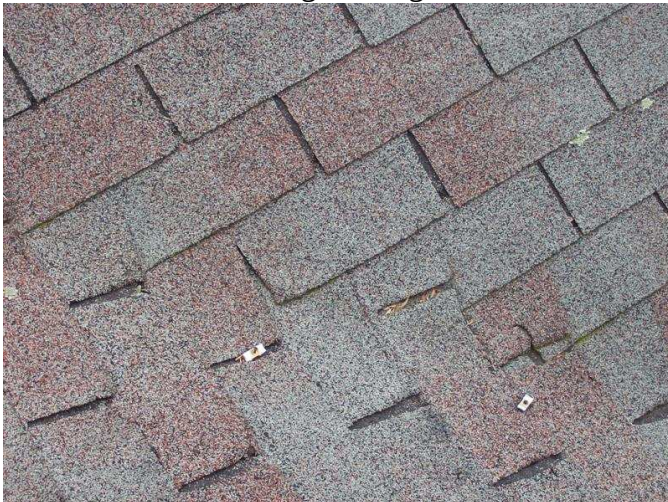
The valley on the other side is showing signs that water is penetrating the valley and this is noted in the Seller's Disclosure. There are several places where the shingles are damaged and curled.

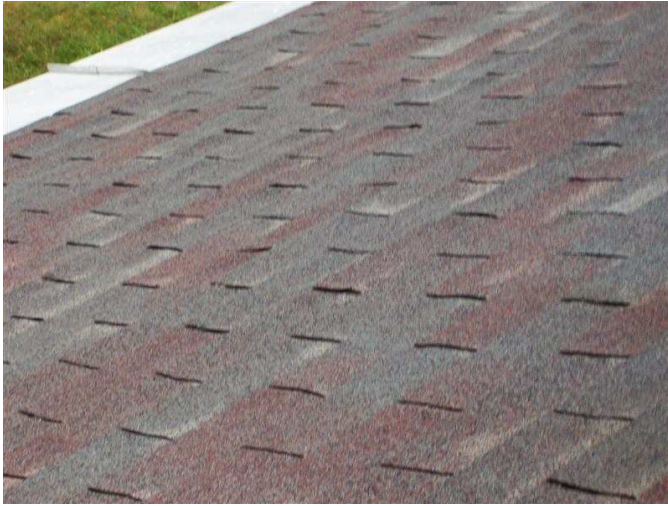
The overall roof is very curled and the shingles are in poor condition.

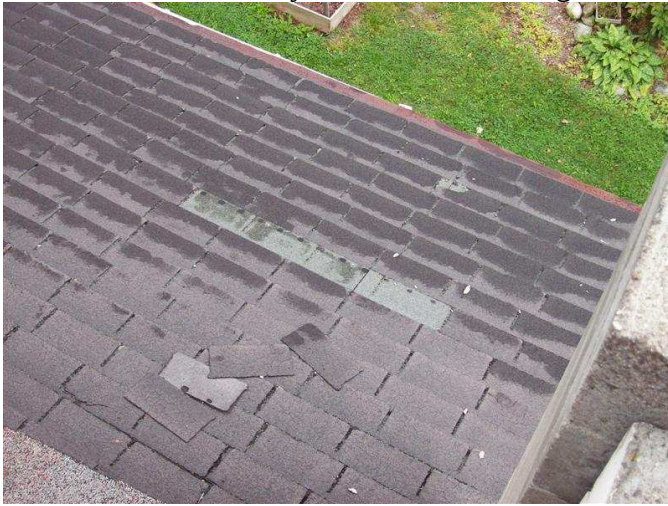
The lower west hip roof is in very poor condition with missing shingles, heavy degradation, and exposed sheathing. The sheathing on the hip along the south edge is no longer attached and will require review by a roofing contractor or builder.

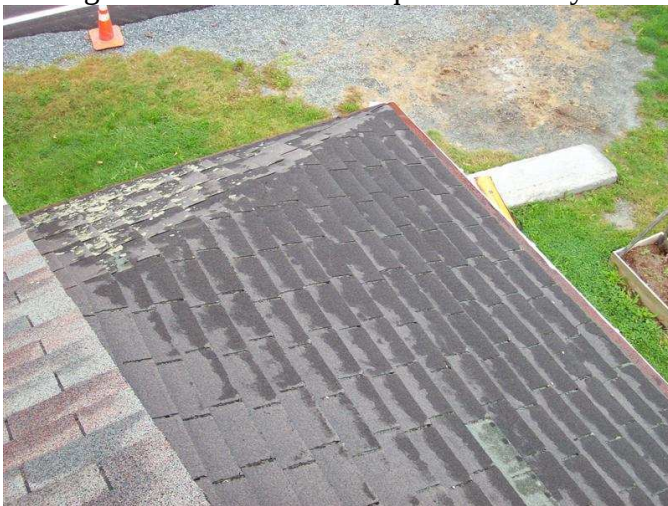
The drip edge flashing is quite rusted and not protected by the roof covering. There are locations where fasteners are exposed.

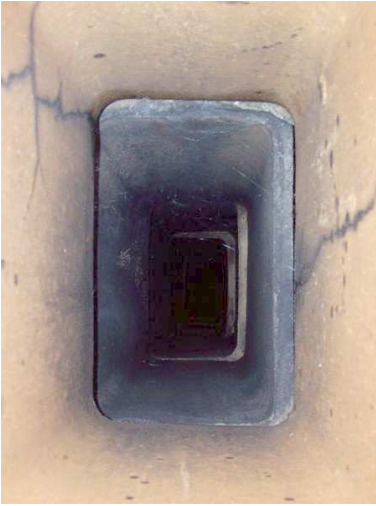
This is the flue of the white chimney. The first tile is cracked and will need to be replaced.

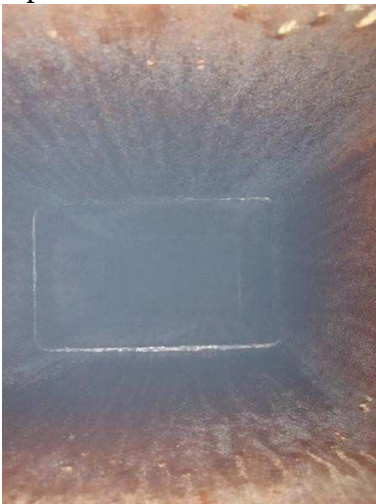
This is the flue for the woodstove off the kitchen it appeared to be clean and intact.

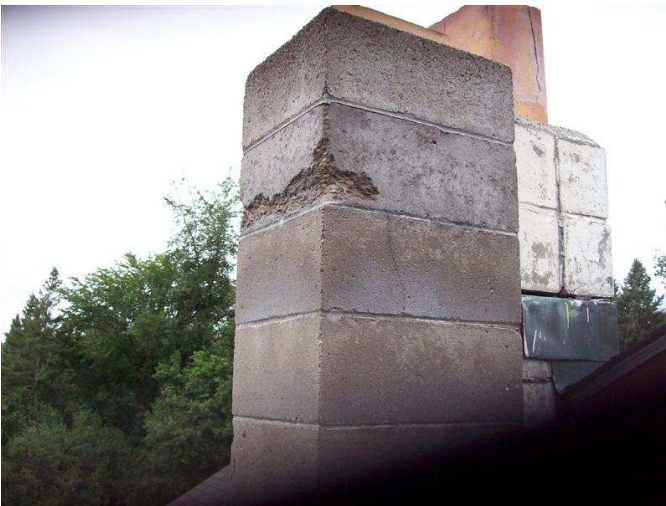
This view of the grey chimney shows that the masonry will need some repair as the block surface has spalled off. The third course of block is also split vertically from the pressure transferring from the other chimney.

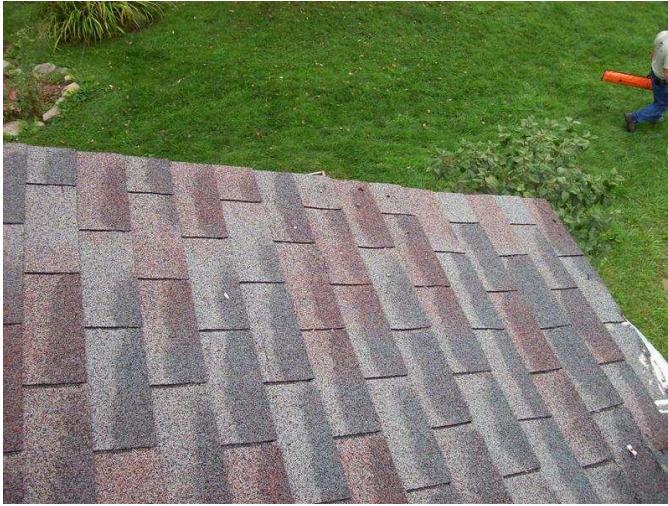
This portion of the roof has several nails poking out of the shingles. These could produce leaks.

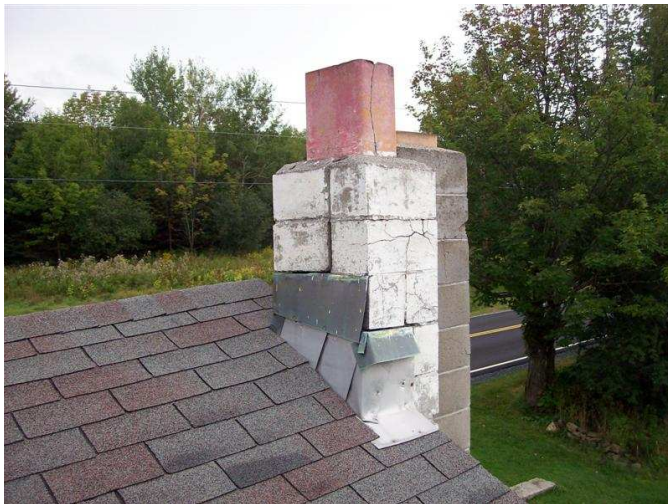
This is a view of the very poor condition of the white masonry chimney. The blocks are coming apart and the flashing is no longer properly sealing out moisture.

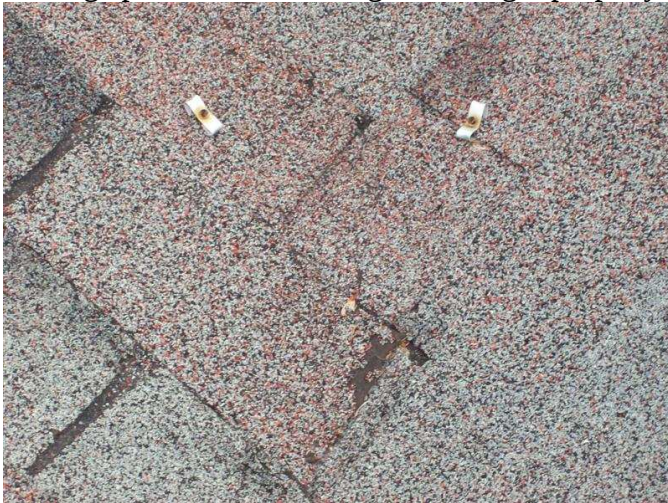
This is a photo of a hole through the shingles.

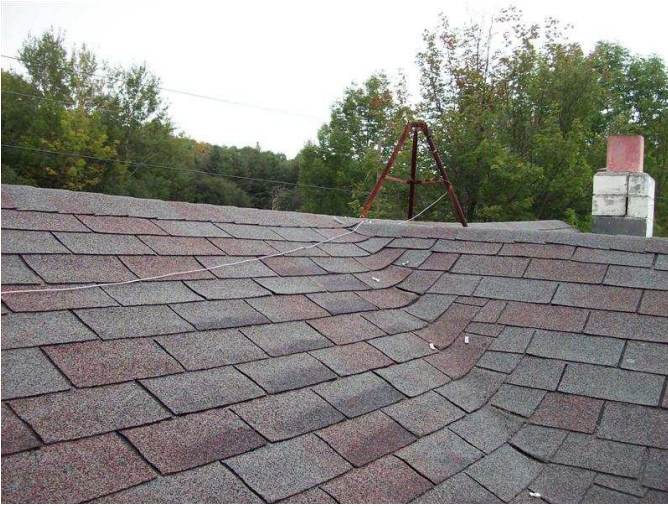
This photo shows the sag in the ridge of the main portion of the dwelling.

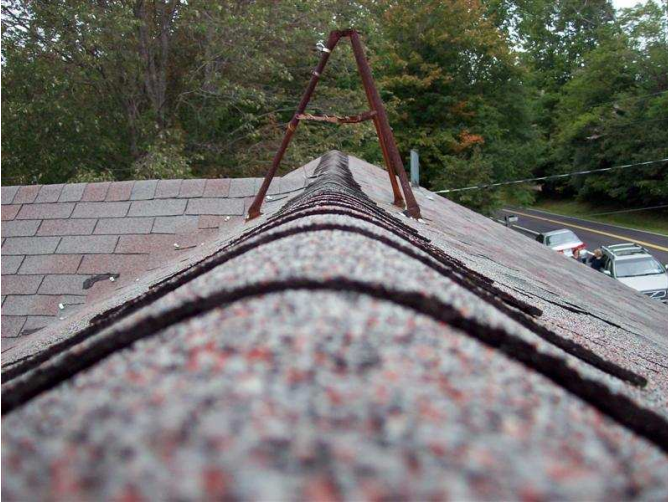
This photo shows a different view of the sag in the ridge. The sag may be from normal settling but could also be a sign of a deteriorated ridge. Very minimal ventilation is provided for the attic space.

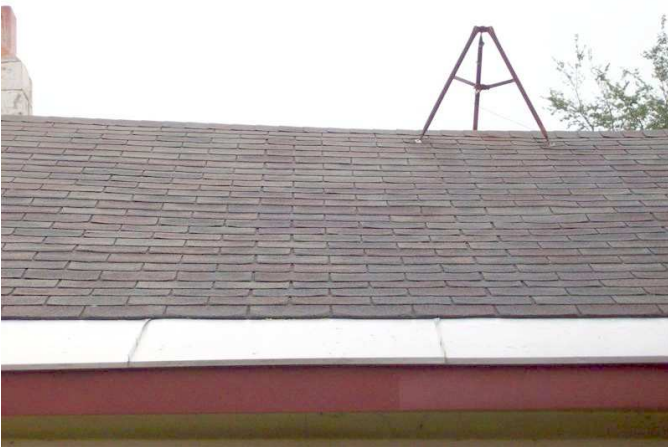
This photo shows the wavy roof surface. If the roof is stripped and replaced there may be some sub sheathing that will need to be replaced as well as some rafters should be reviewed. The roofing system has a very minimal ventilating system installed.

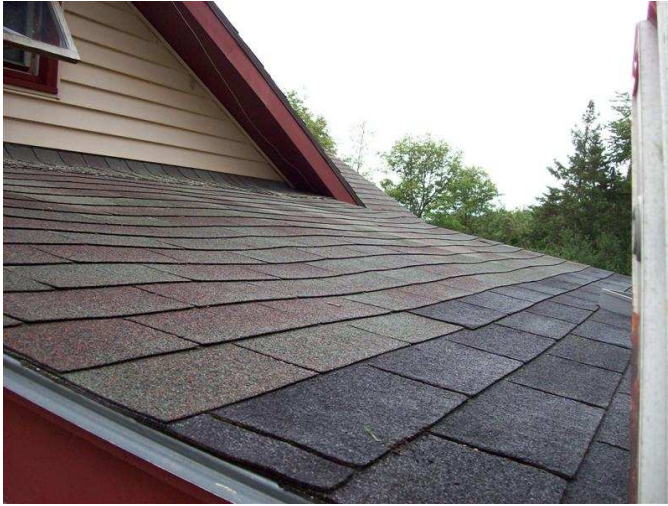
This roof over the covered porch has a wavy surface and from the inside shows that moisture has gotten through at some point. This will and can soften the sheathing and cause it to be wavy.

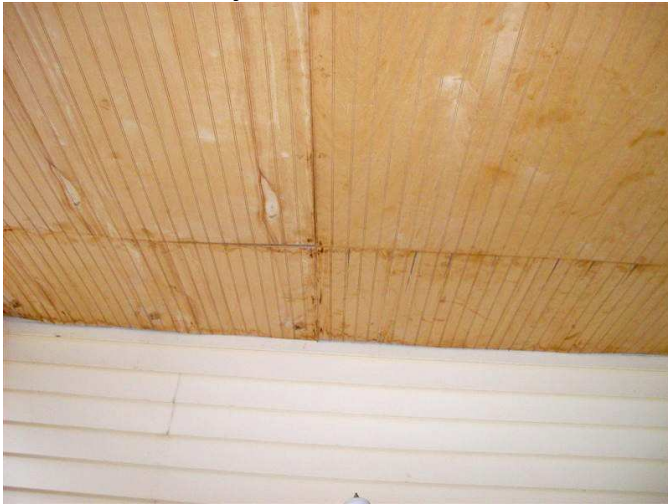
This is the underside of the covered porch showing the water stains.

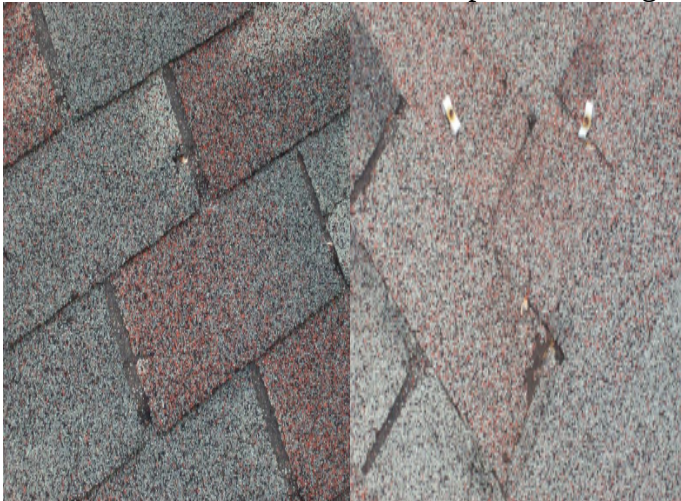
More damaged roofing

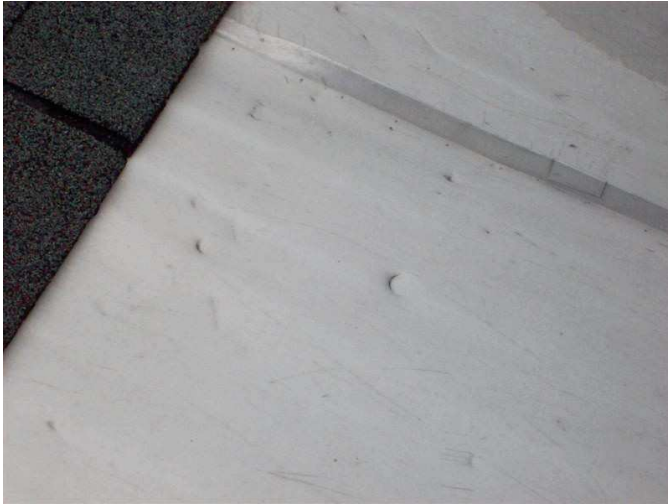
The aluminum ice guard has a hole in it.

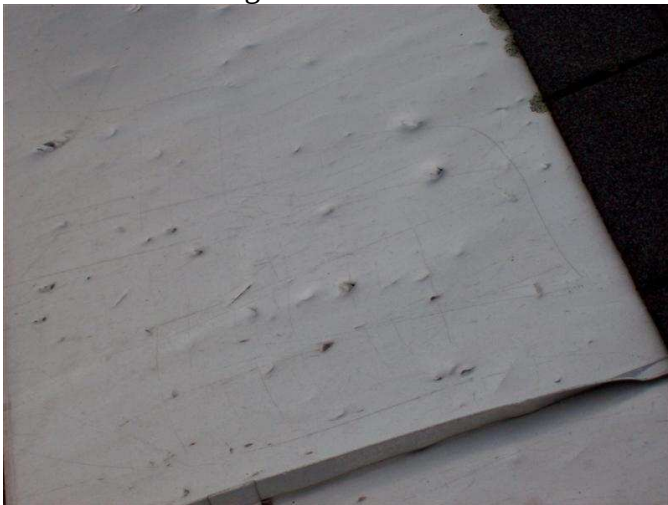
This is an additional photo showing the damage to the ice guard on the roof.

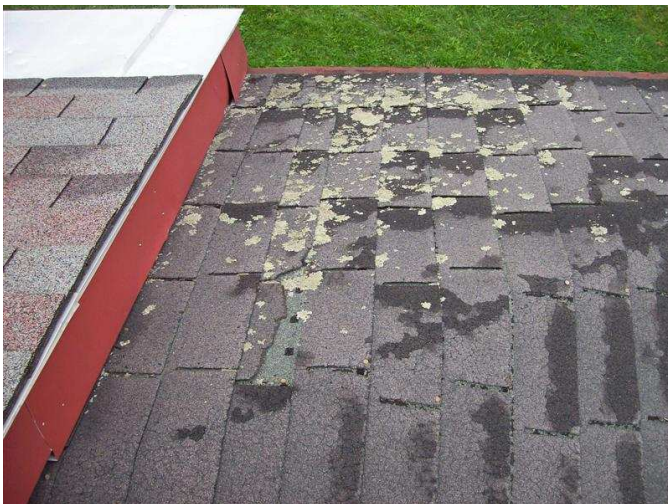
More broken shingles and some algae is growing on the roof.

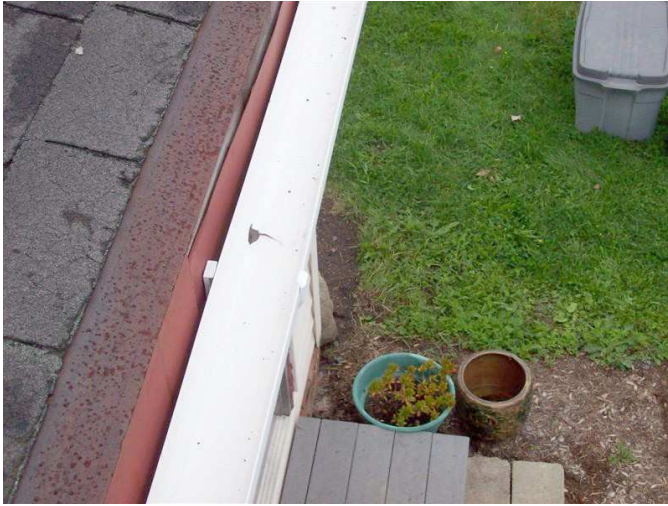
This gutter has a hole in it.

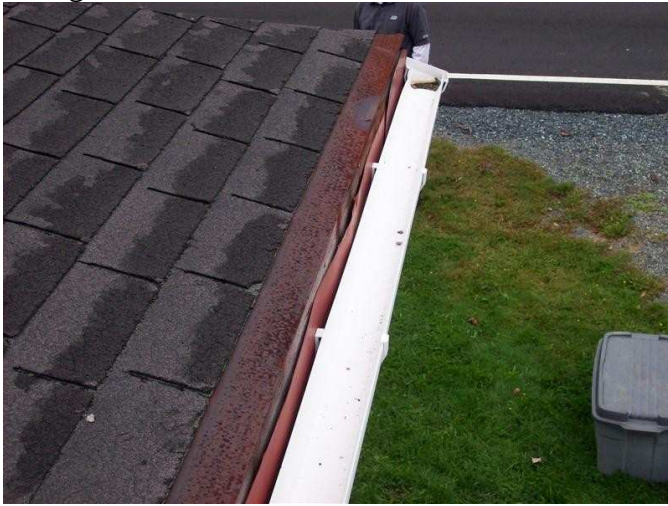
The metal fascia is not installed properly to protect the wood fascia from water damage.

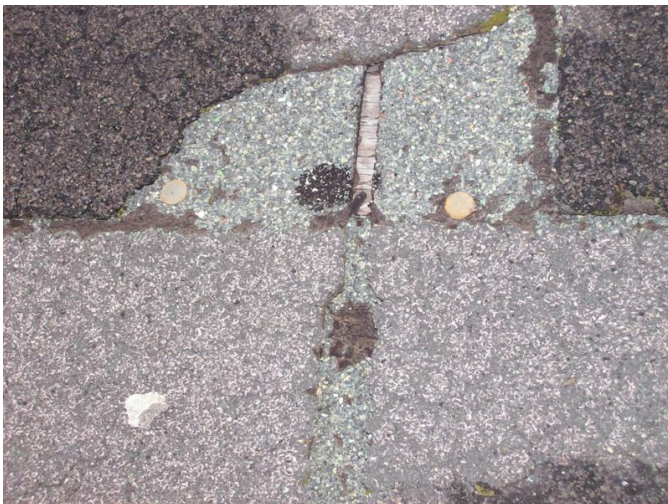
This photo shows the wood sub sheathing is showing through the roofing shingles as well as exposed fasteners.

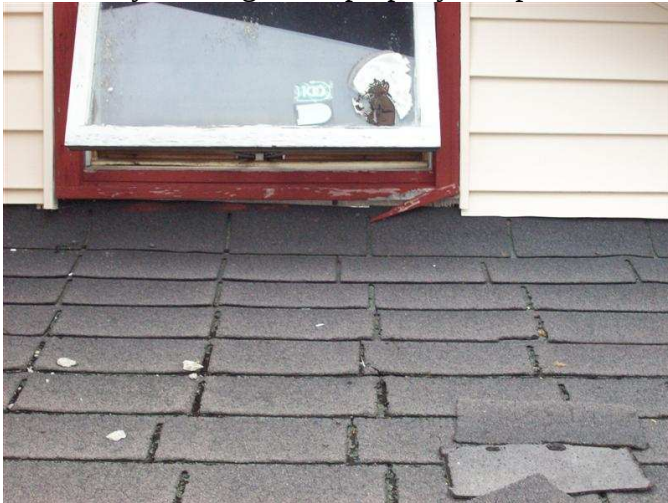
This photo shows a casement window has broken trim. It also shows some broken tabs of shingle on the roof.

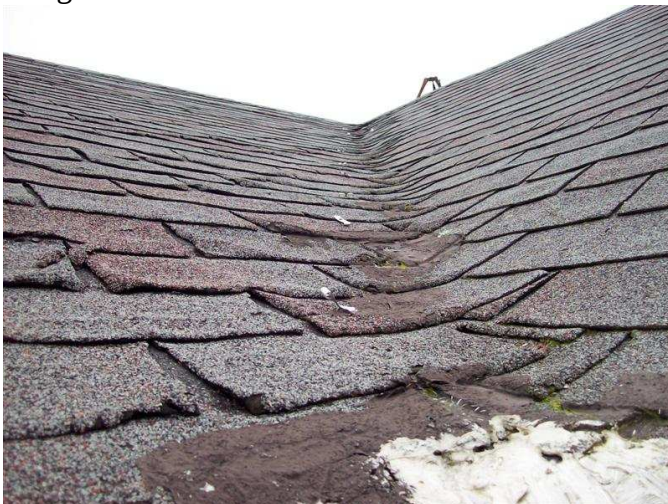
This is a view looking up the valley showing the very poor condition of the shingles.

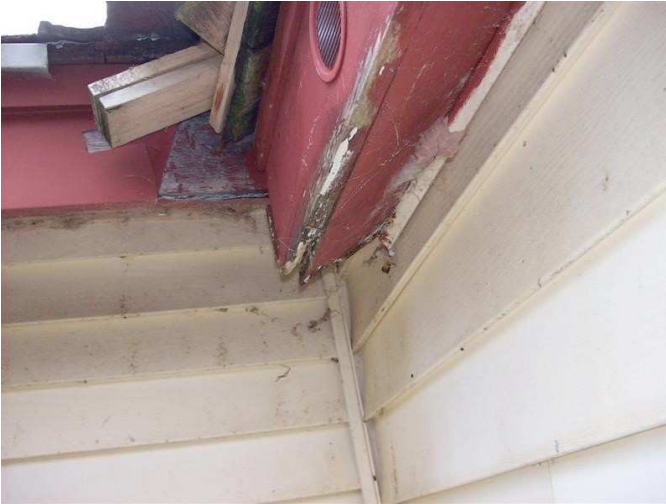
This is the underside of the valley. Here the soffit and fascia are very soft and punky from the valley flashing leaking.

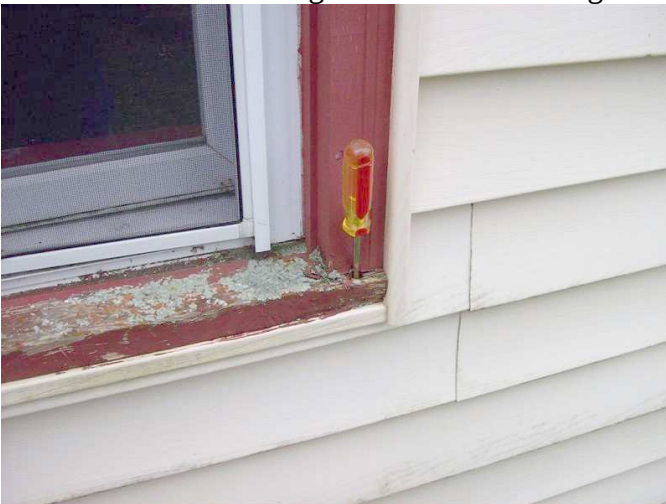
This window sill will need to be replaced as it is very soft and punky.

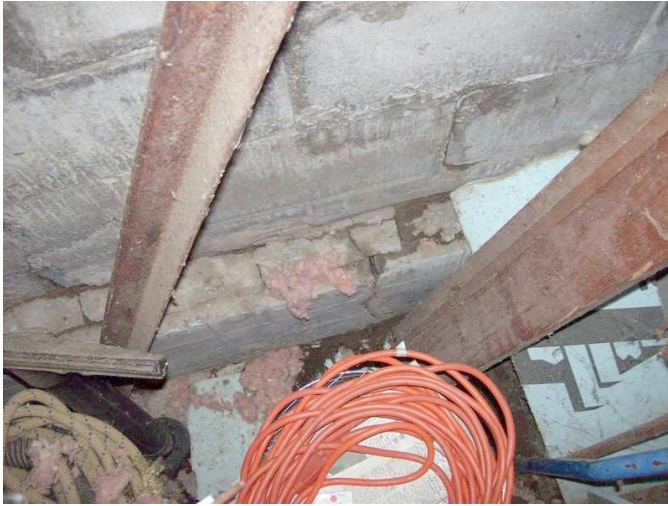
This is a photo of the footing on the rear of the dwelling. The footing is cracked and settling.

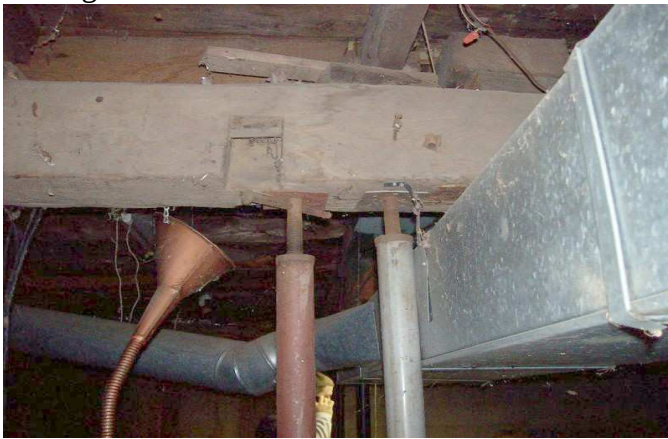
These pipe columns are not appropriate for supporting a structure. The columns should be concrete filled with proper base and top plates securely anchored. Also the column spacing on all the basement columns is not adequate to uniformly support the load bearing beams.

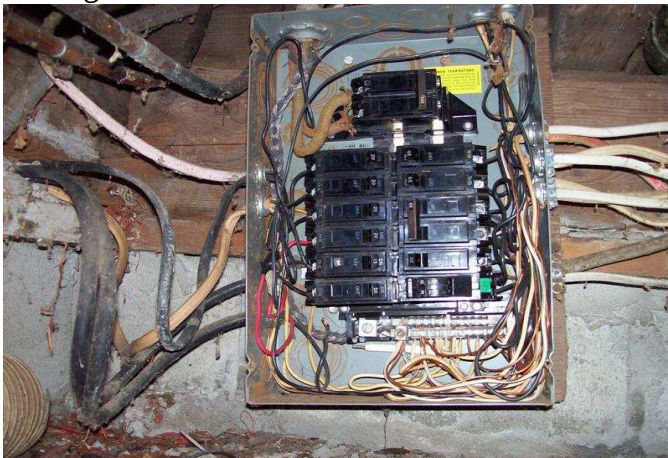
The main electrical panel has improperly terminated wires in the panel which are still hot or live. There are several breakers which have been double tapped and this is not permitted. There is also another panel on the first floor. It was not accessible. There are circuits in which the amperage of circuit breakers exceeds the wire size. The entire electrical system should be reviewed by a licensed electrician and any deficiencies corrected. This panel does not have enough room for all the circuits installed and will need to be upgraded.

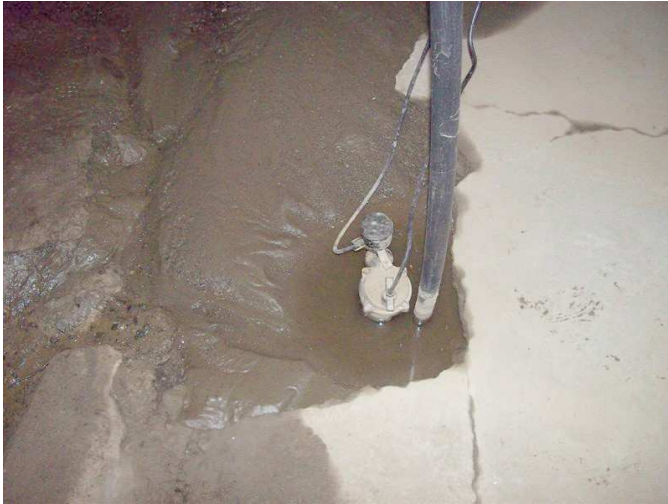
This sump pump needs to be installed in a proper sump well. The power supply to the sump pump should be installed as a GFCI outlet not an extension cord. Also a back up alarm system should be provided should the pump fail to operate.

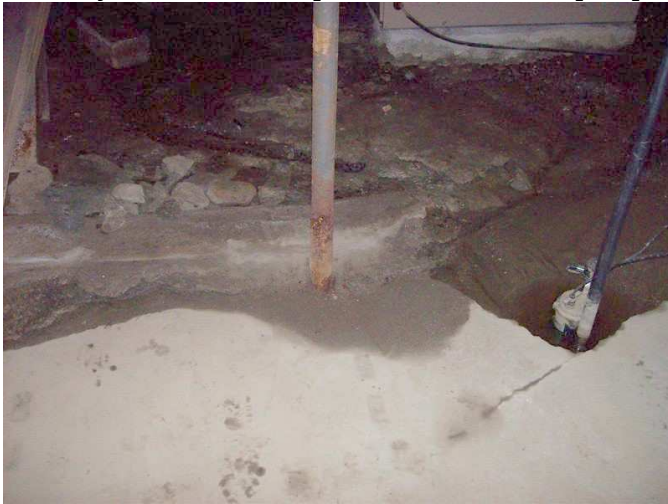
Several of the steel shoring columns are ready to be replaced. The bottoms of the columns are quite corroded and some have rusted completely through.

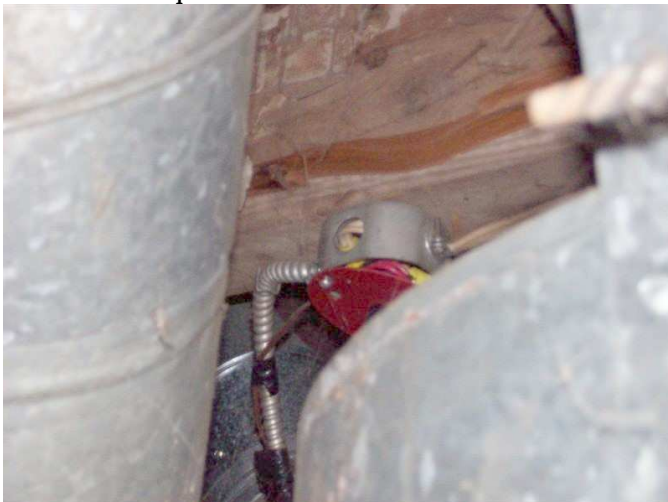
The thermal safety shut off for the furnace is not properly installed.

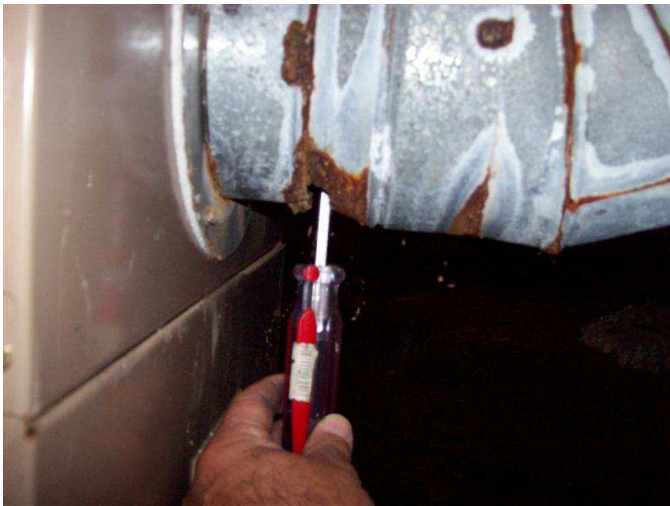
The vent piping for the boiler is completely compromised and rusted through. This must be replaced as soon as possible as it is a carbon monoxide hazard.

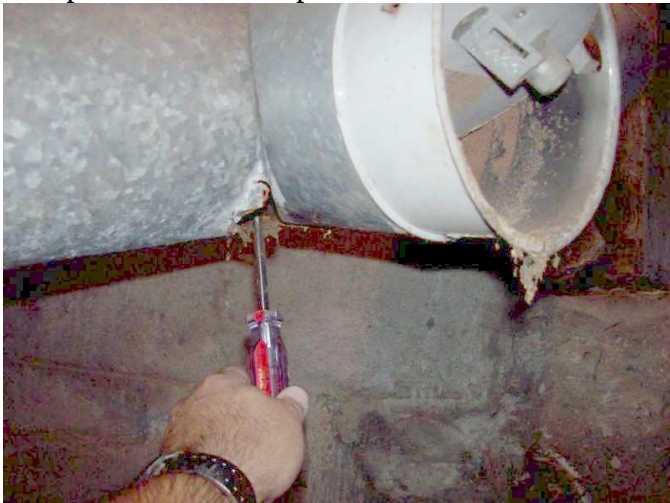
This is another location where the vent to the furnace is rusted through and the barometric damper is not functioning properly.

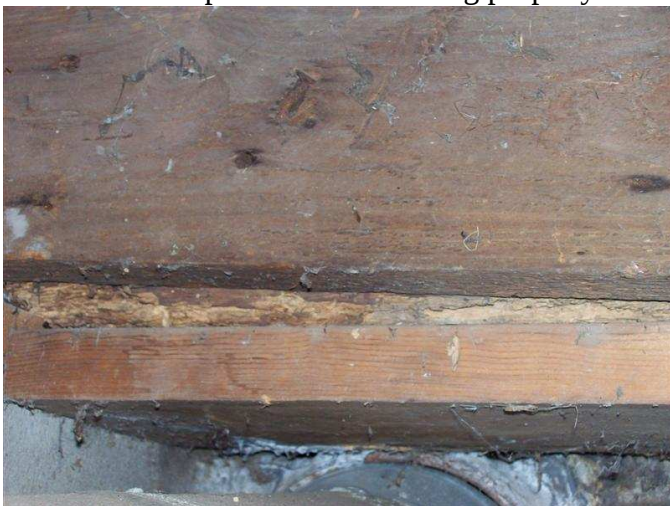
This is a photo showing there are signs of wood boring insect damage. It is also important to note that this combustible wood is too close to the vent from the furnace.

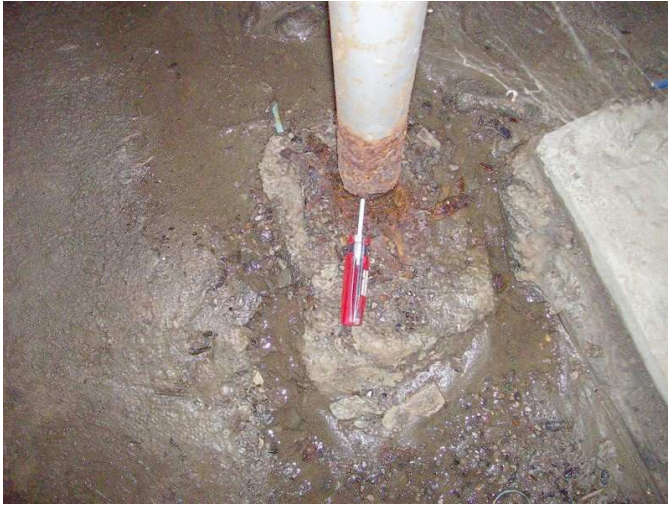
This column in the basement is rusted through and ready for replacement.

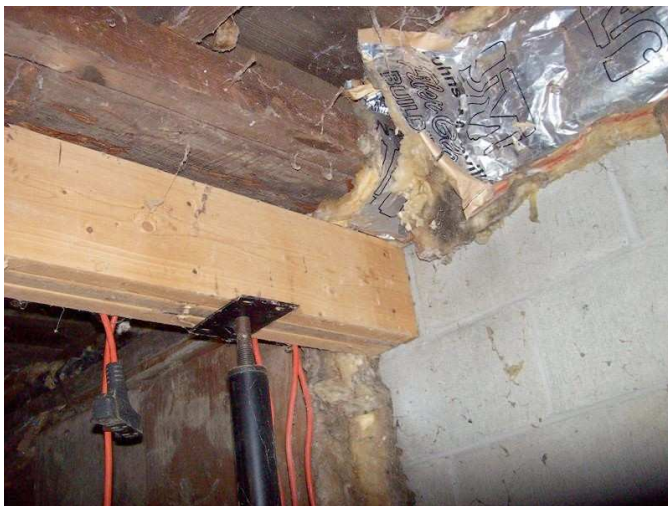
This system of repairing a beam is not correct. The new beam is not tight against the existing beam, not anchored to the wall, and not bearing on a proper masonry pilaster. It is also important to note that the column is not anchored to the beam and the new beam is not anchored properly to the beam it is supporting.

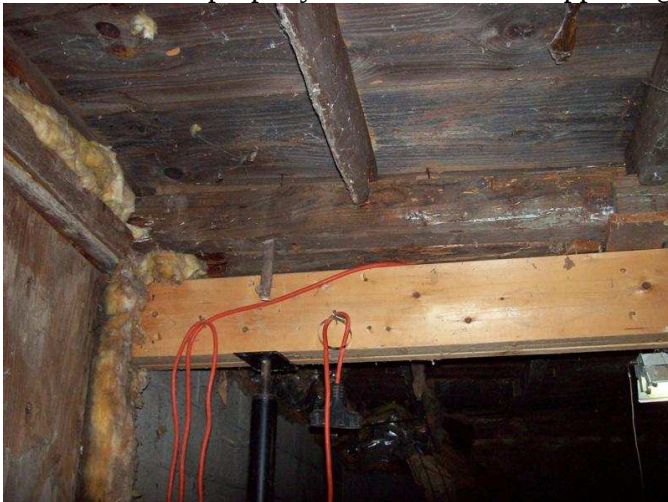
This is another view of the shoring beam.

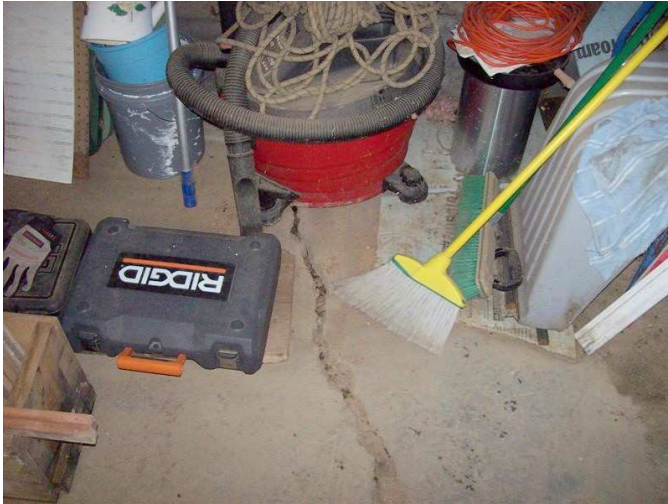
This photo shows the large settlement crack in the concrete floor.

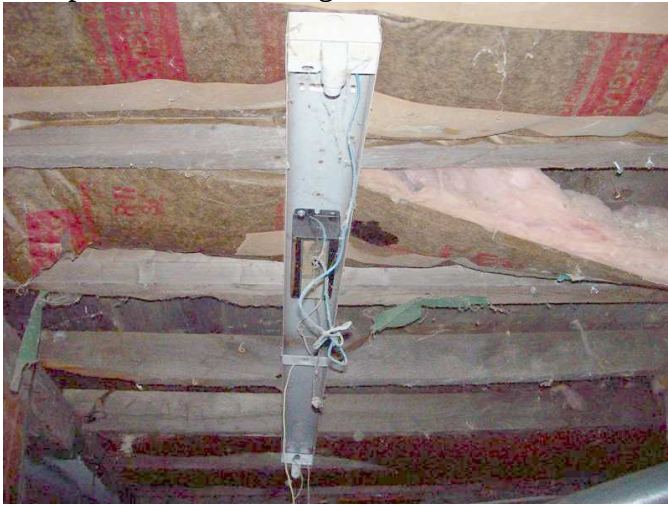
This light fixture in the basement should be removed if it can not be repaired.

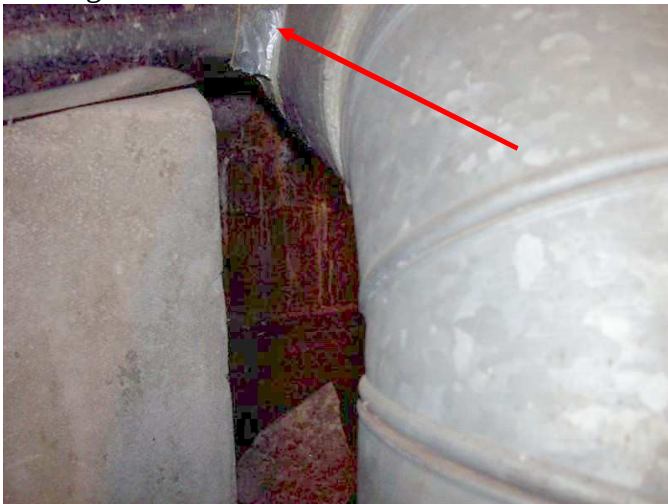
The connection of the hot water heater vent to the furnace vent is not properly installed. The connection should be by a properly installed thimble connection. Cutting a hole into the main vent and sticking the pipe into the hole could cause it to become blocked and back vent into the dwelling causing risks to health and safety.

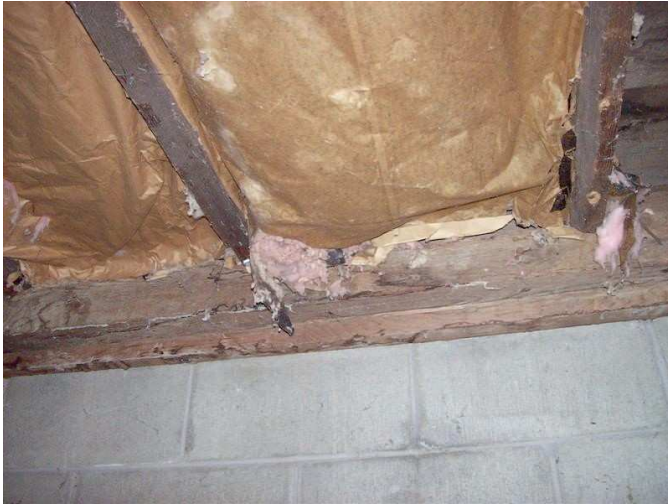
This photo shows that mice have been nesting in the insulation for the basement.

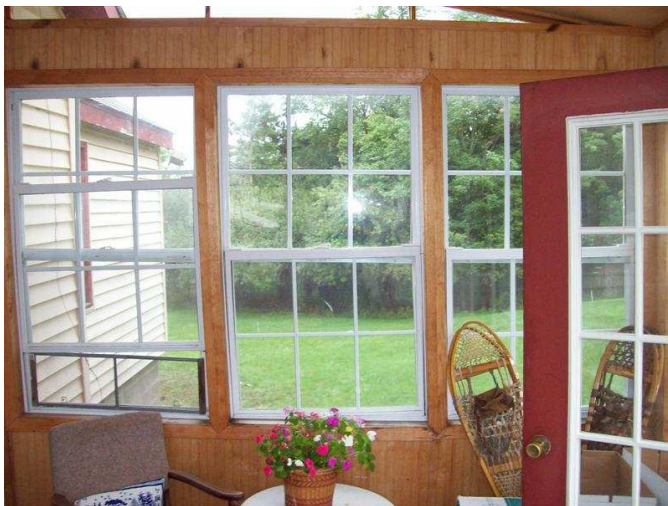
This photo shows the porch windows failing under the stress of the porch as it is settling. The window to the left will not close properly over the screen insert. It touches at the top on the left but not on the top on the right.
