**Freedom Under The Sun** LLC.  
A Vermont Home And Property Inspection Company  
39 Carver Street Brandon, Vermont 05733  
Telephone 1-888-247-1299 Fax (802) 247-1244  
E-mail: [Kirk@Vermont-HomeInspector.com](mailto:Kirk@Vermont-HomeInspector.com)  
Website: [www.Vermont-HomeInspector.com](http://www.Vermont-HomeInspector.com)

89 Trescott Road, Hanover, New Hampshire 03750

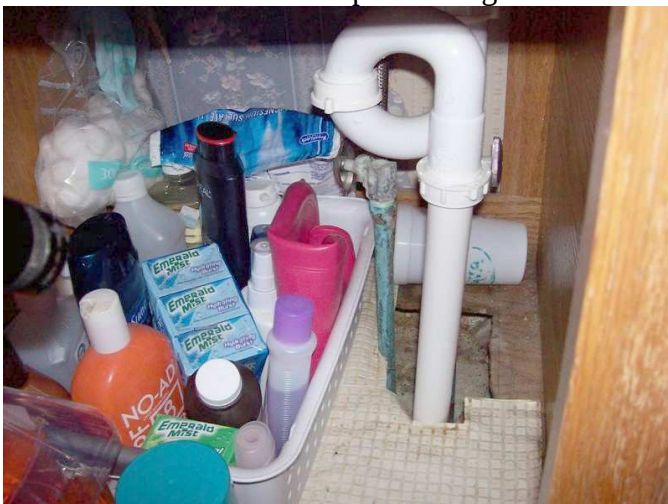
Under the bathroom vanity in the laundry area the water supply piping has had a leak and damaged the floor of the cabinet.

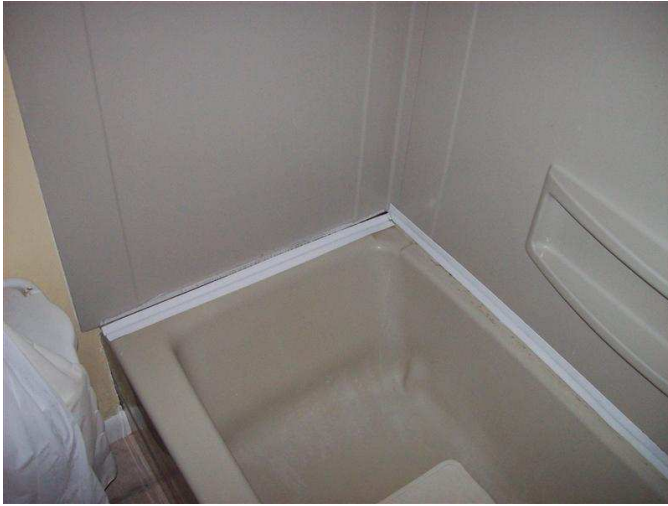
The bath tub is quite stained and the caulking is very poor. This will need to be repaired to keep the water from getting behind the tub.

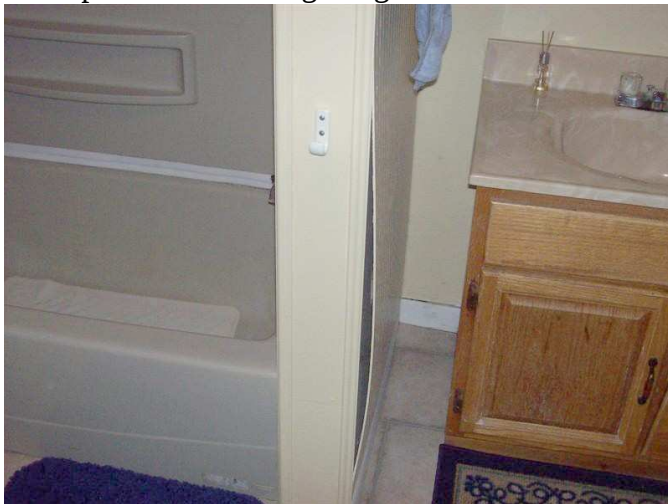
The finish wall covering is peeling off the wall.

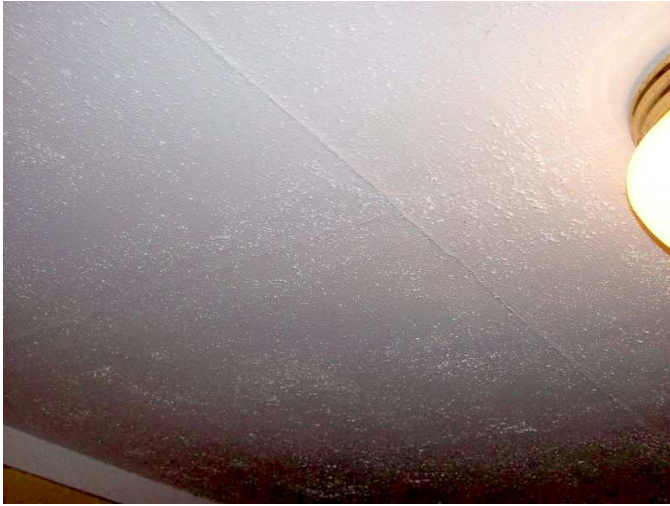
The ceiling in the bathroom is poorly finished and should be repaired.

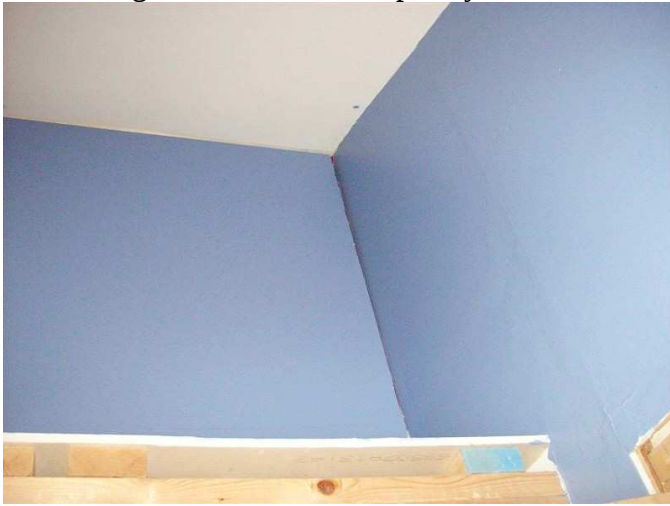
The interior of the dwelling has several locations where the corners of the sheetrock are not finished. There are openings for closets and interior doors not completed with trim.

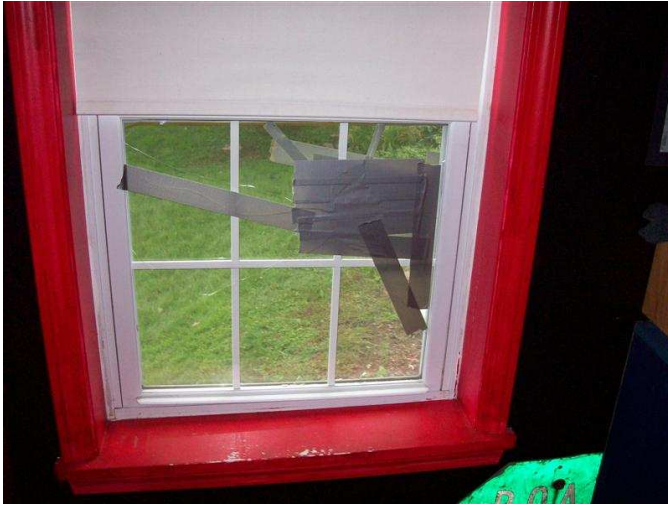
This window is broken and will need to be repaired. The repair is not simply getting a glass cut to fit the entire lower window sash. It will have to be taken out and taken to a glazing shop so they can order a replacement panel to repair the window.

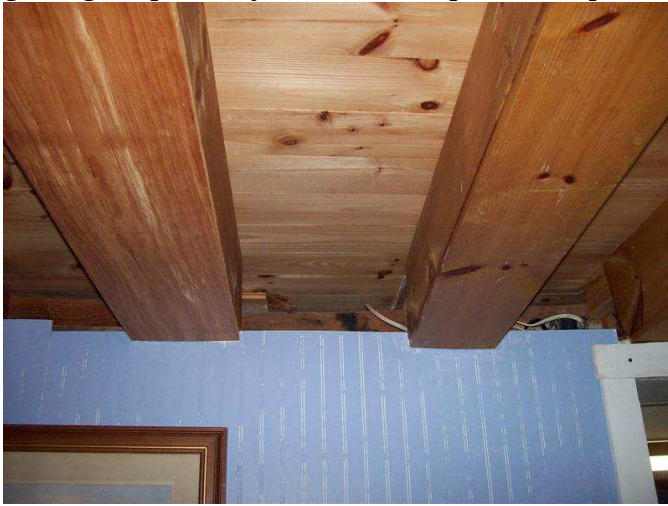
There are several locations at the ceiling in the living room that are incomplete and need to be finished.
