**Freedom Under The Sun** LLC.  
A Vermont Home And Property Inspection Company  
39 Carver Street Brandon, Vermont 05733  
Telephone 1-888-247-1299 Fax (802) 247-1244  
E-mail: [Kirk@Vermont-HomeInspector.com](mailto:Kirk@Vermont-HomeInspector.com)  
Website: [www.Vermont-HomeInspector.com](http://www.Vermont-HomeInspector.com)

89 Trescott Road, Hanover, New Hampshire 03750

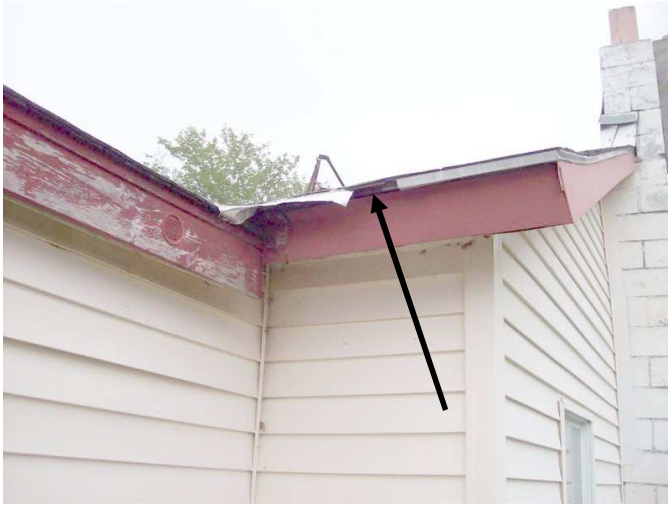
This valley flashing is not properly completed and the drip edge is not complete.

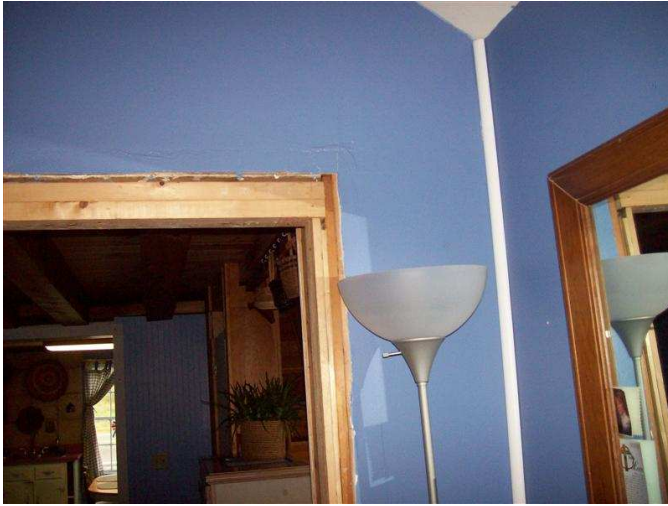
This door opening is not finished.

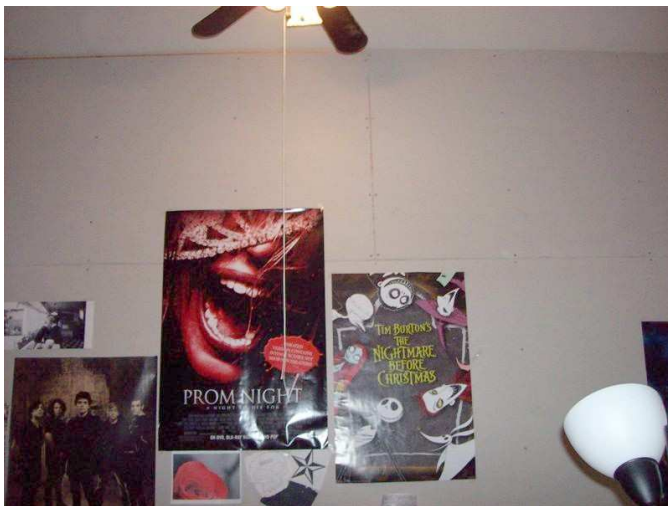
This wall is not finished with tape and sheetrock mud.

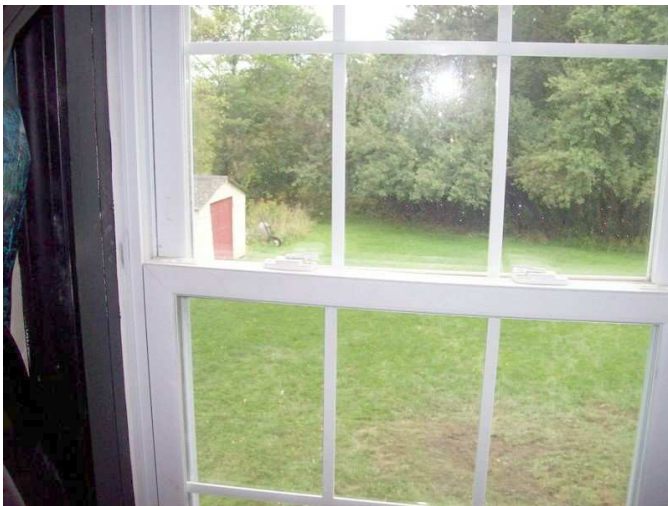
This window will not close as the window is not installed plumb and straight or there is settling in the exterior wall that is pulling the window casing out of plumb.
