**Freedom Under The Sun** LLC.  
A Vermont Home And Property Inspection Company  
39 Carver Street Brandon, Vermont 05733  
Telephone 1-888-247-1299 Fax (802) 247-1244  
E-mail: [Kirk@Vermont-HomeInspector.com](mailto:Kirk@Vermont-HomeInspector.com)  
Website: [www.Vermont-HomeInspector.com](http://www.Vermont-HomeInspector.com)

89 Trescott Road, Hanover, New Hampshire 03750

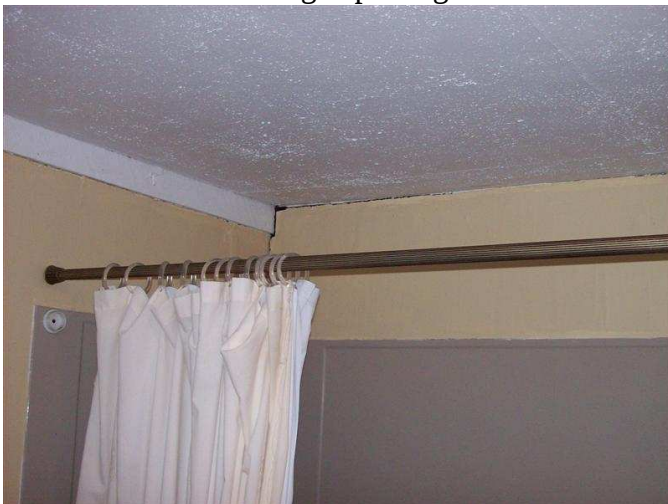
The wall to the bathroom is showing some signs of settling and it needs to be sealed properly.

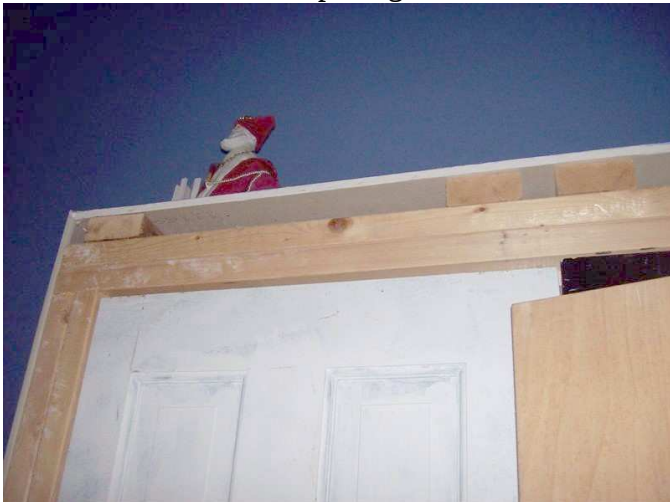
This closet is not finished.
